PRELIMINARY NONDESTRUCTIVE EVALUATION MANUAL FOR THE SPACE SHUTTLE

**PRELIMINARY NONDESTRUCTIVE EVALUATION MANUAL
FOR THE SPACE SHUTTLE**

APPENDIX TO FINAL REPORT

**LOCKHEED-GEORGIA COMPANY
A DIVISION OF LOCKHEED AIRCRAFT CORPORATION
MARIETTA, GEORGIA 30063**

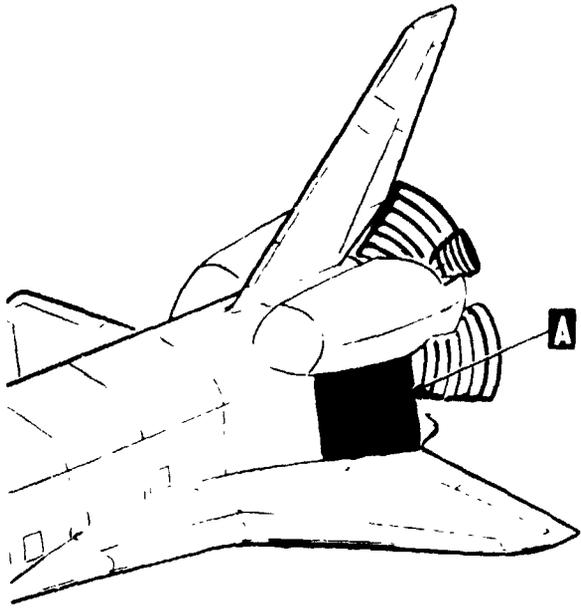
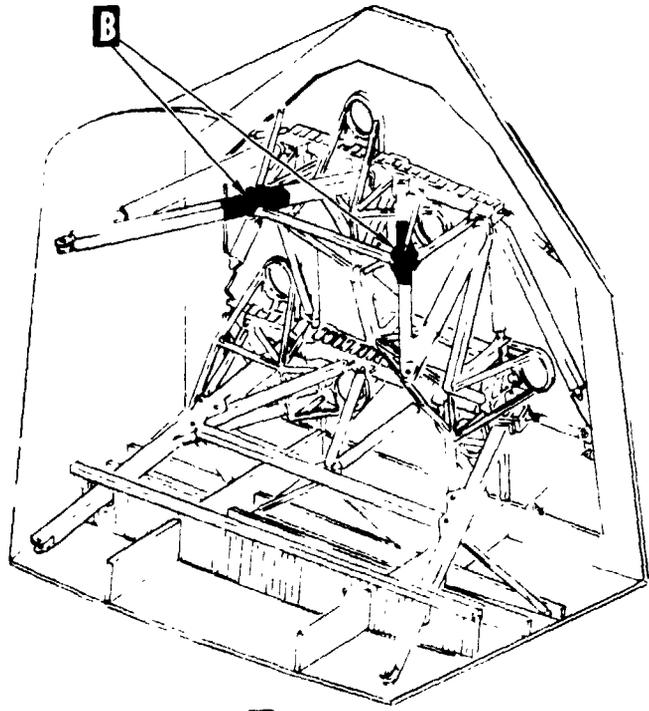
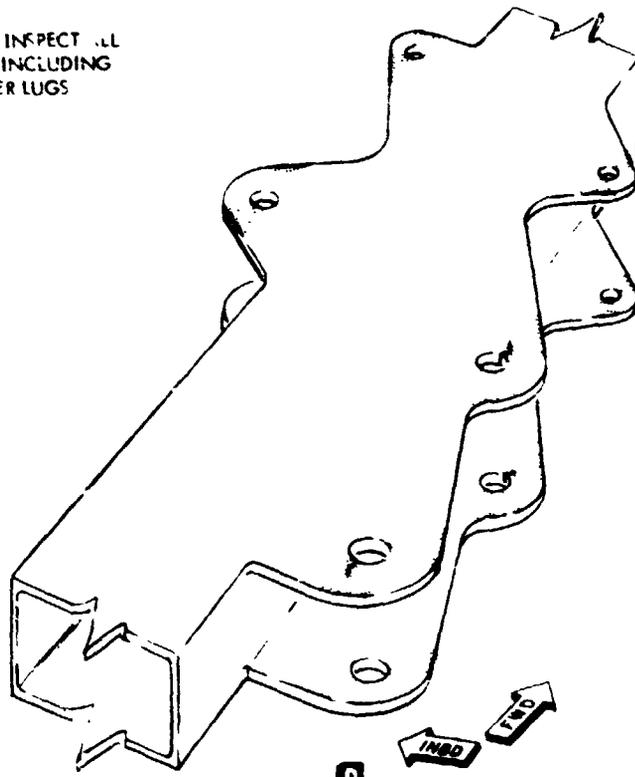
Figure 4-11. Upper Thrust Shelf Support Truss Attach (Sheet 1 of 2)

TRUSS ATTACH. The upper thrust shelf principal members are stabilized by titanium (6A1-4V) alloy trusses attached to them at X_o 1377.5, Z_o 430, and $Y_o \pm 44$. Engine thrust and vibroacoustic loads could eventually cause fatigue damage in the clevis bolt holes or the lug-to-base transitions.

DEFECTS: Radial cracks at clevis bolt holes and part-through cracks at lug-base fillets.

NDT TECHNIQUES: Primary: Ultrasonic shear wave (para. 1.5.5.3 B) for clevis bolt holes, eddy current (para. 1.5.4.4) for fillets and edges of attach fittings.

A
UPPER THRUST SHELF
TRUSS ATTACH FITTINGS
X 1380

ULTRASONIC INSPECT ALL
LUG AREAS, INCLUDING
TRUSS MEMBER LUGS

B
TRUSS ATTACHMENT
(ALTERNATE DESIGN)

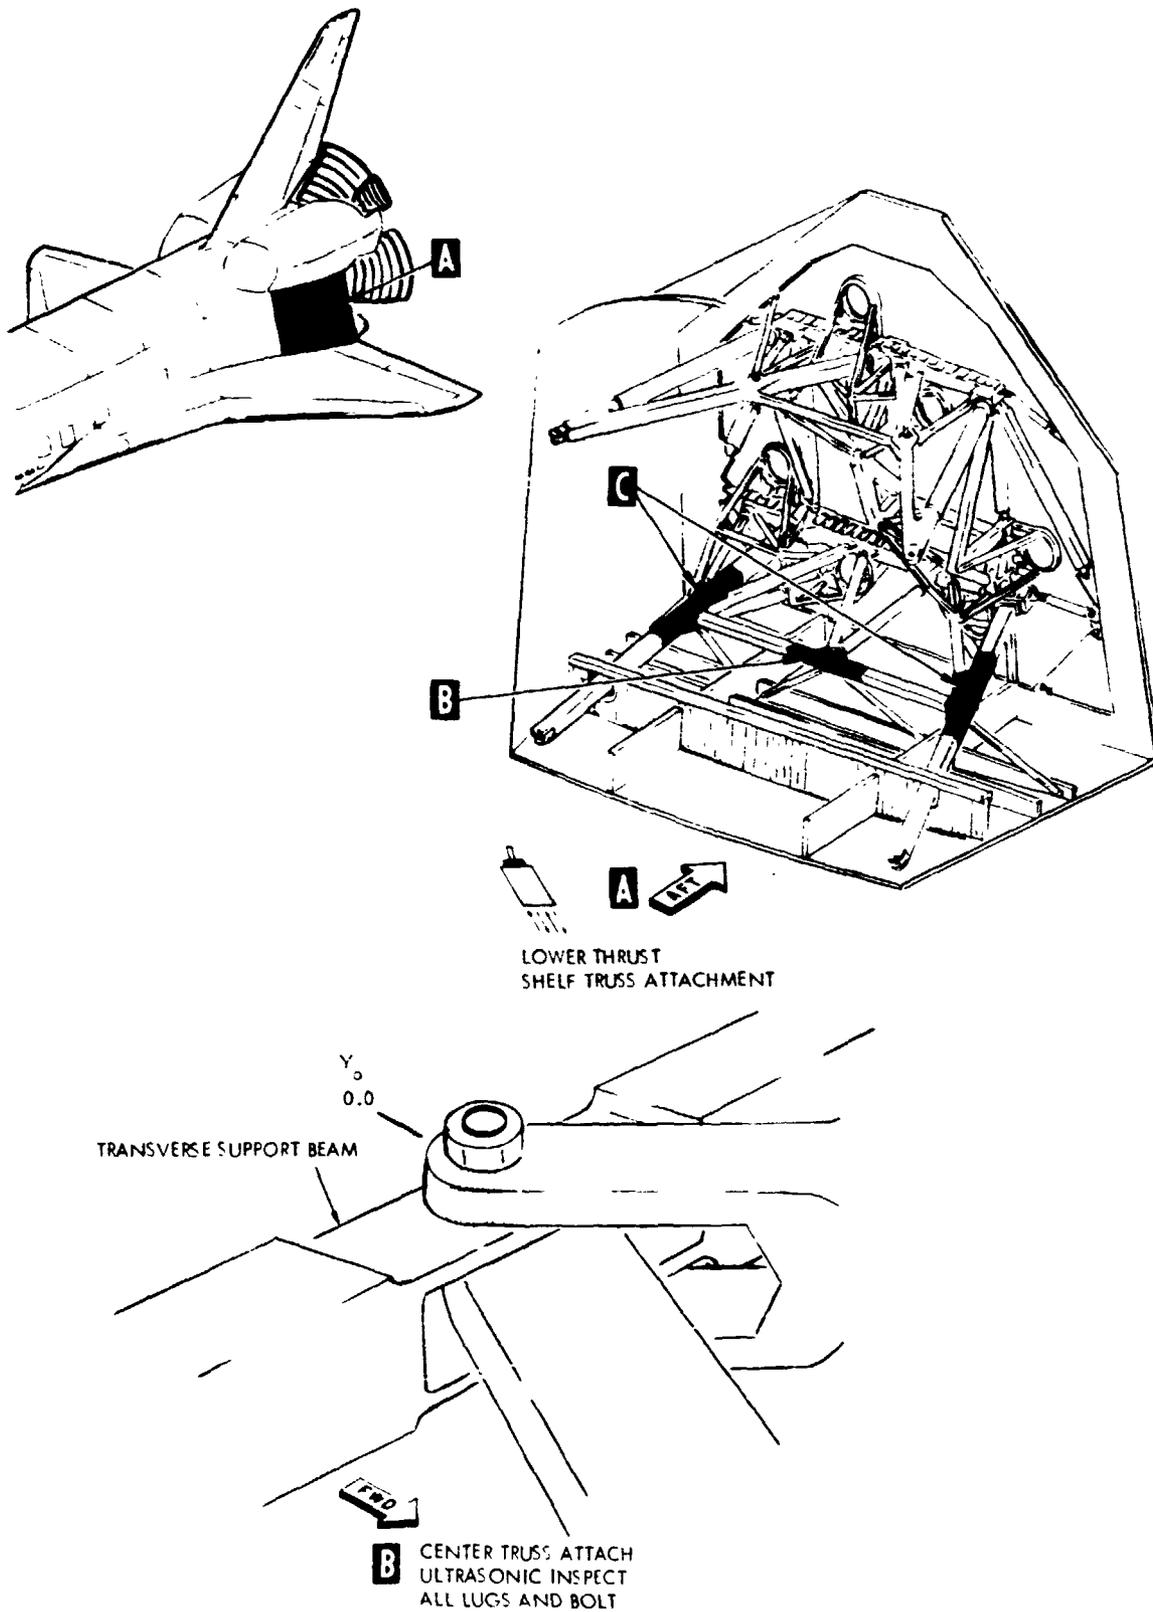
Figure 4-12. Lower Thrust Shelf Support Truss Attach (Sheet 1 of 2)

TRUSS ATTACH. The lower thrust shelf principal members are stabilized by titanium (6Al-4V) alloy trusses attached to them at X_o 1394, X_o 308 and Y_o 0.0 and $Y_o \pm 74$. Engine thrust loads and vibroacoustic loads or engine-out condition could eventually cause fatigue damage in the clevis bolt holes or the lug-to-truss transitions.

DEFECTS: Radial cracks at clevis bolt holes and part-through cracks at lug-base fillets.

NDT TECHNIQUES: Primary: Ultrasonic shear wave (para. 1.5.5.3 B) for clevis bolt holes, eddy current (para. 1.5.4.4) for fillets and edges.

DIFFUSION BONDED TRUSS
ATTACHMENT
INSPECT ALL LUGS INCLUDING
TRUSS MEMBER LUGS

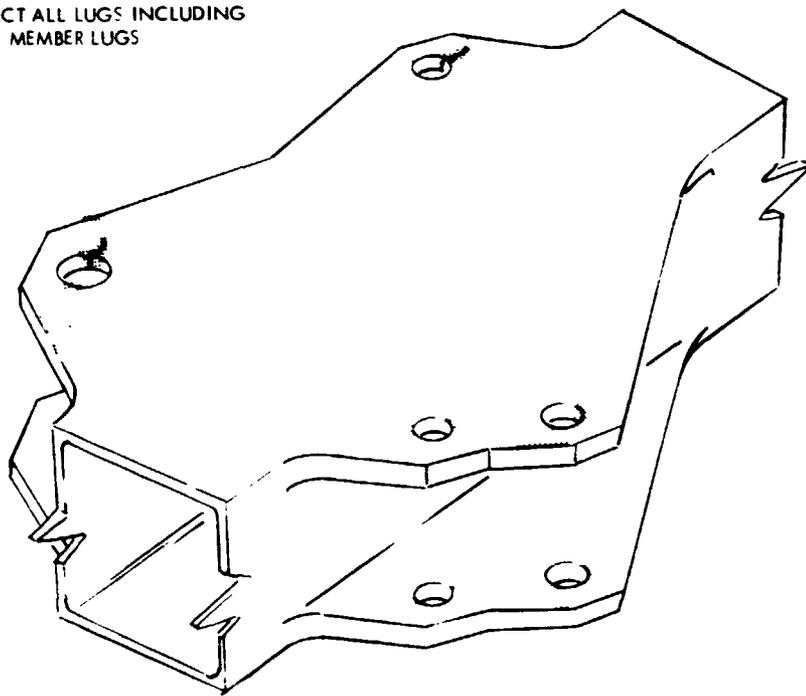
Figure 4-12. Lower Thrust Shelf Support Truss Attach (Sheet 2 of 2)

SIDE (LONGITUDINAL) BEAM
TRUSS ATTACHMENTS
R.H. SHOWN, L.H. OPPOSITE

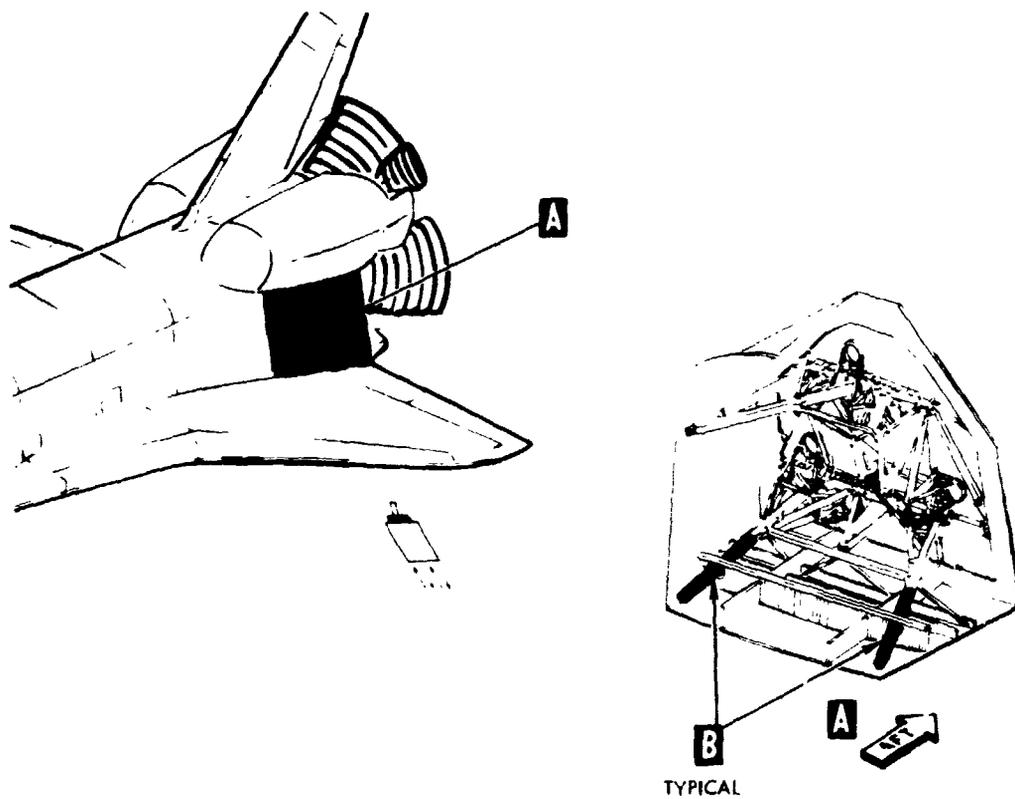
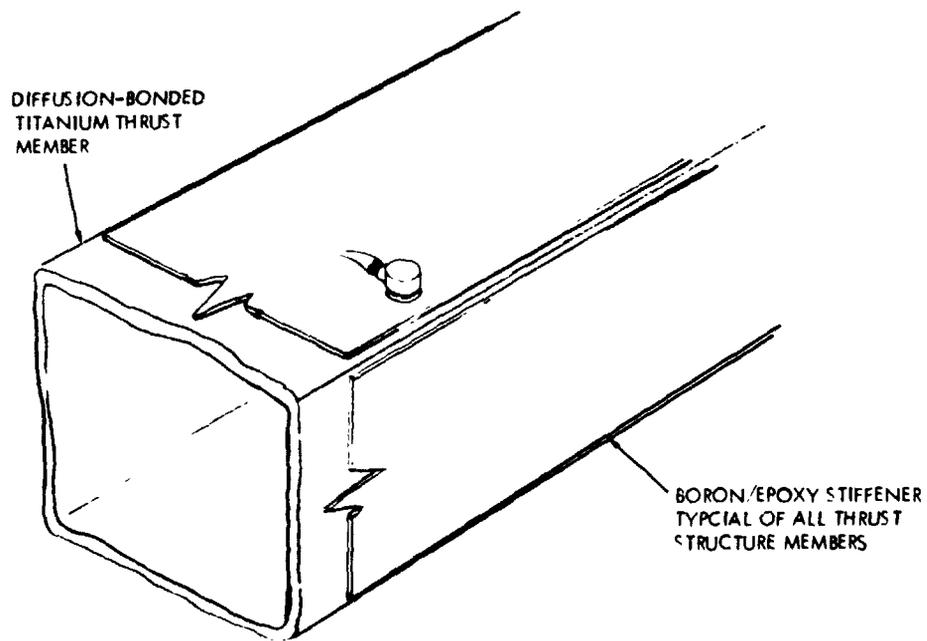
Figure 4-13. Boron/Epoxy-Thrust Structure Bonds

The main engine thrust members are constructed of round and/or square, diffusion-bonded, titanium tubes which contain bonded boron/epoxy stiffeners bonded to the exterior surfaces of the thrust members. Engine compressive thrust loads and high vibroacoustic loads may tend to cause the stiffeners to become disbonded from the tubular thrust members. All thrust structure members containing B/E stiffeners are affected.

DEFECTS: Disbonds at the boron/epoxy to tubular thrust member interface .

NDT TECHNIQUES: Primary: Ultrasonic pulse-echo resonance (para. 1.5.5.6)
Backup: Mechanical pull test if disbond area is larger than TBD inches dia.

B ULTRASONIC INSPECT FOR DIS BONDS BETWEEN STIFFENER AND THRUST MEMBER

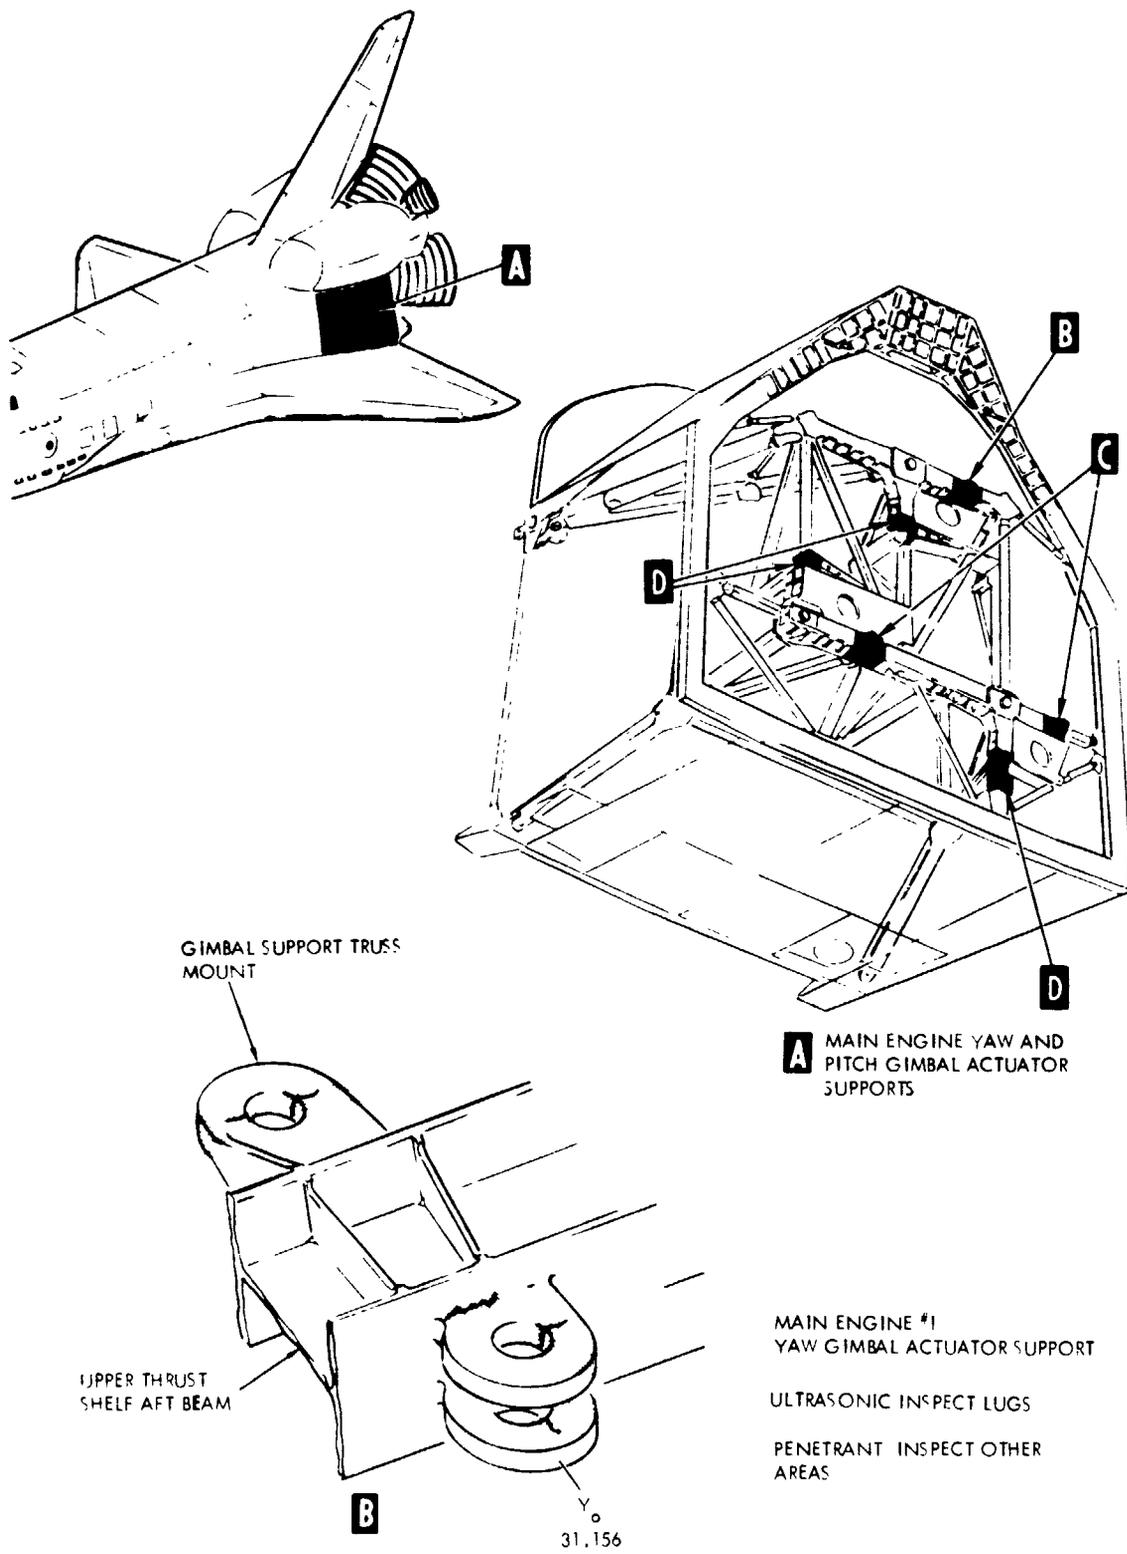
Figure 4-14. Main Engine Gimbal Actuator Points (Sheet 1 of 2)

DEFECTS: Cracks around the lug bolt hole or in the fillet where the lug blends into the base of the attachments. Also similar areas on the truss support on the fwd side of the support beams.

NDT TECHNIQUES: Primary: Ultrasonic shear wave (para. 1.5.5.3B) and eddy current (para. 1.5.4.4)

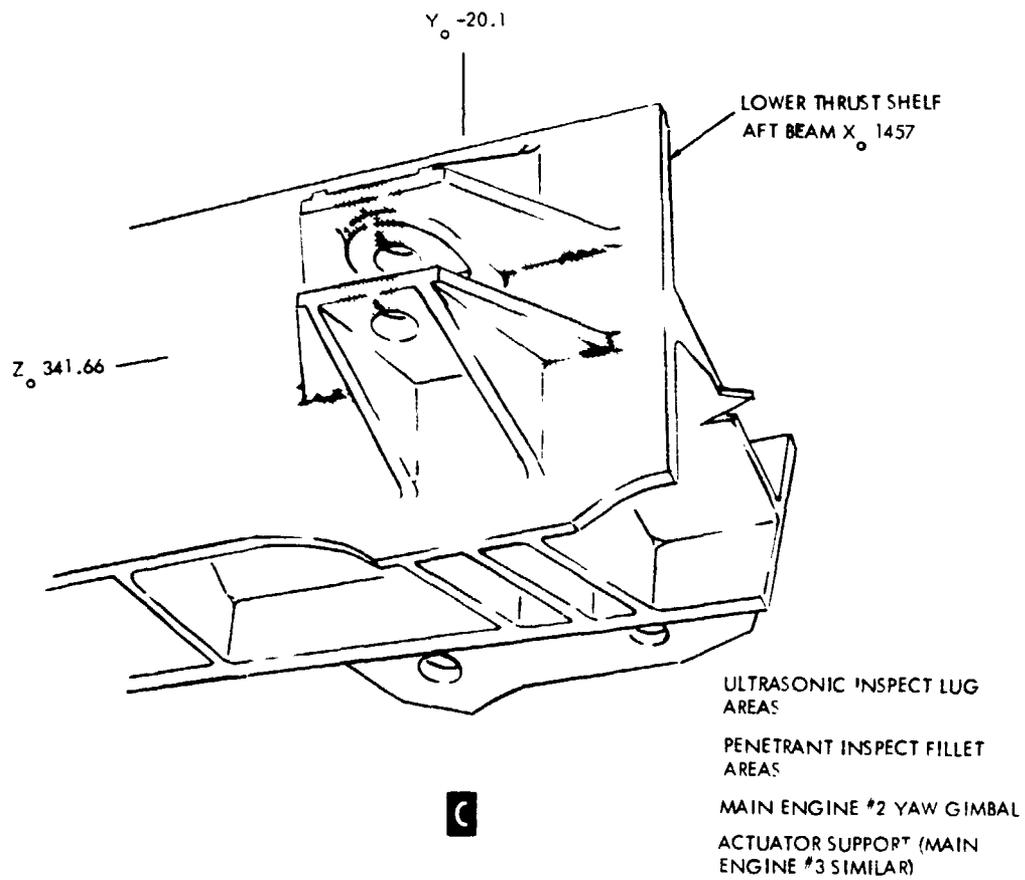
Figure 4-14. Main Engine Gimbal Actuator Points (Sheet 2 of 2)

MAIN ENGINE PITCH GIMBAL ACTUATOR SUPPORTS OF SIMILAR NATURE

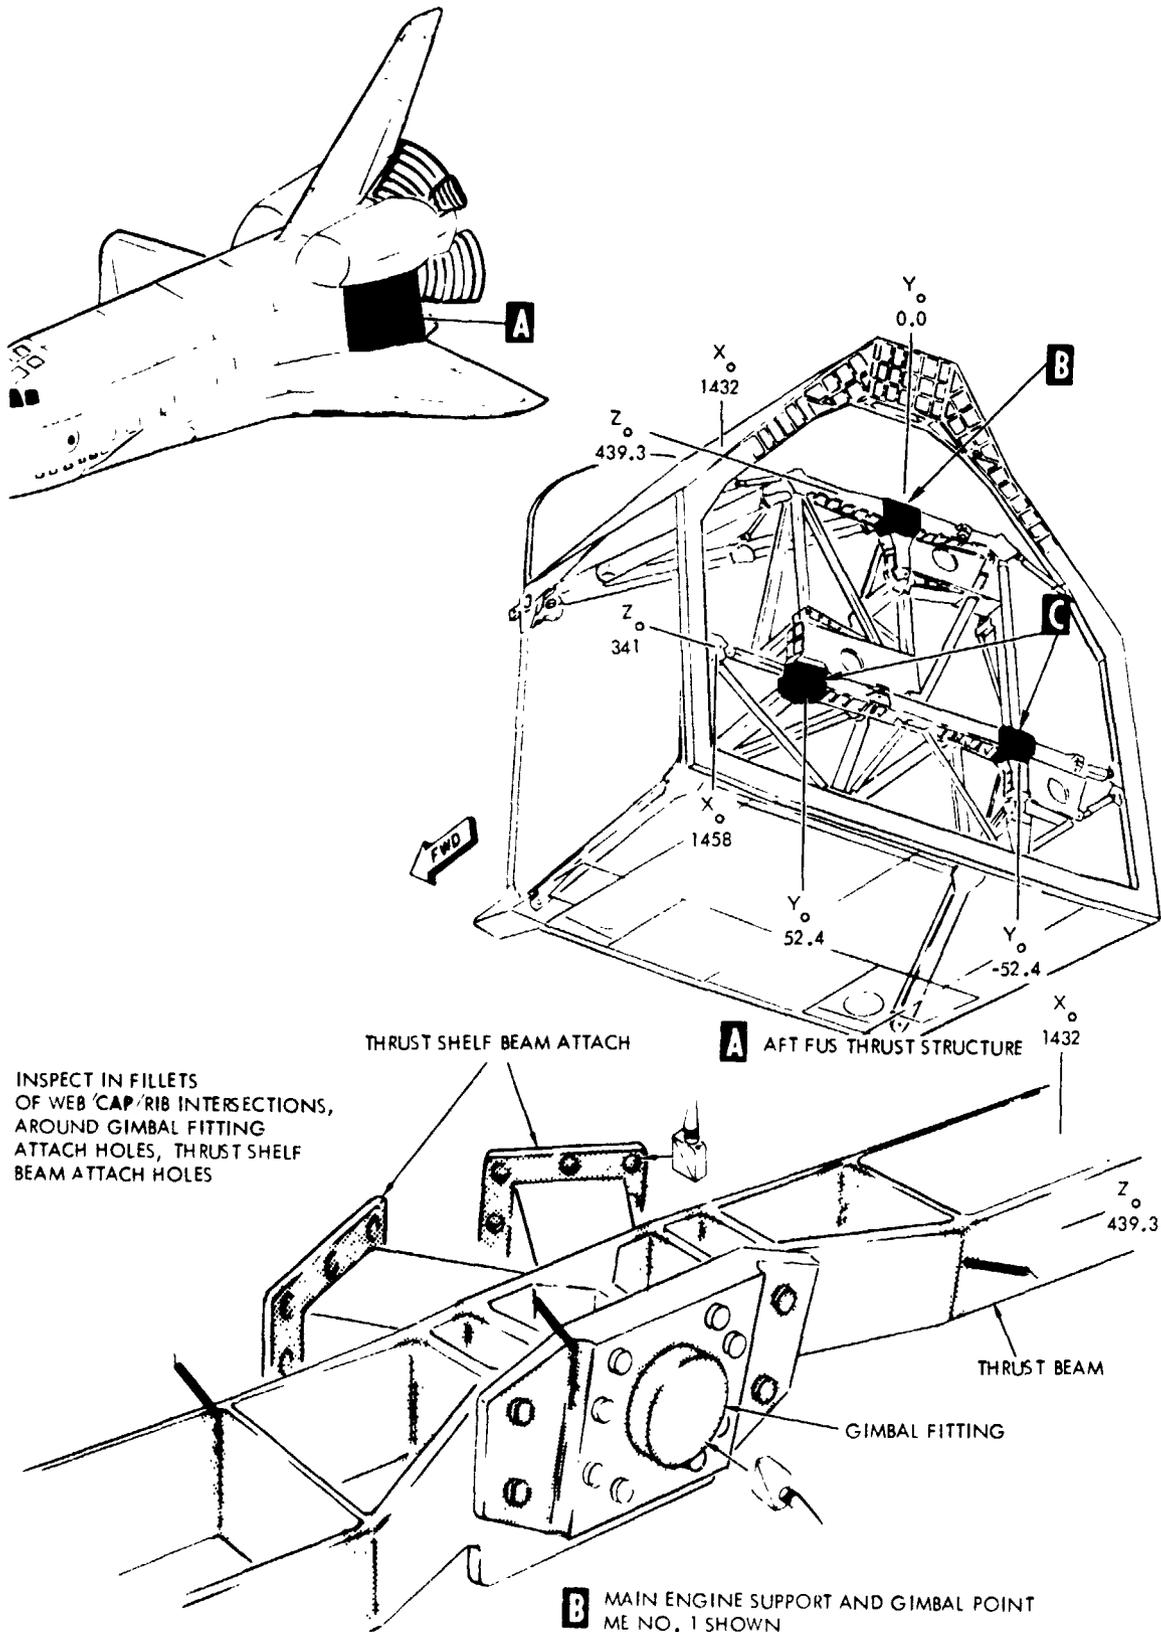
Figure 4-15. Main Engine Support and Gimbal Points (Sheet 1 of 2)

DEFECTS: Cracks in the gibal mechanism and in the thrust beam caps and transverse webs in the area defined by a distance of about 30 inches right and left of the engine gibal point.

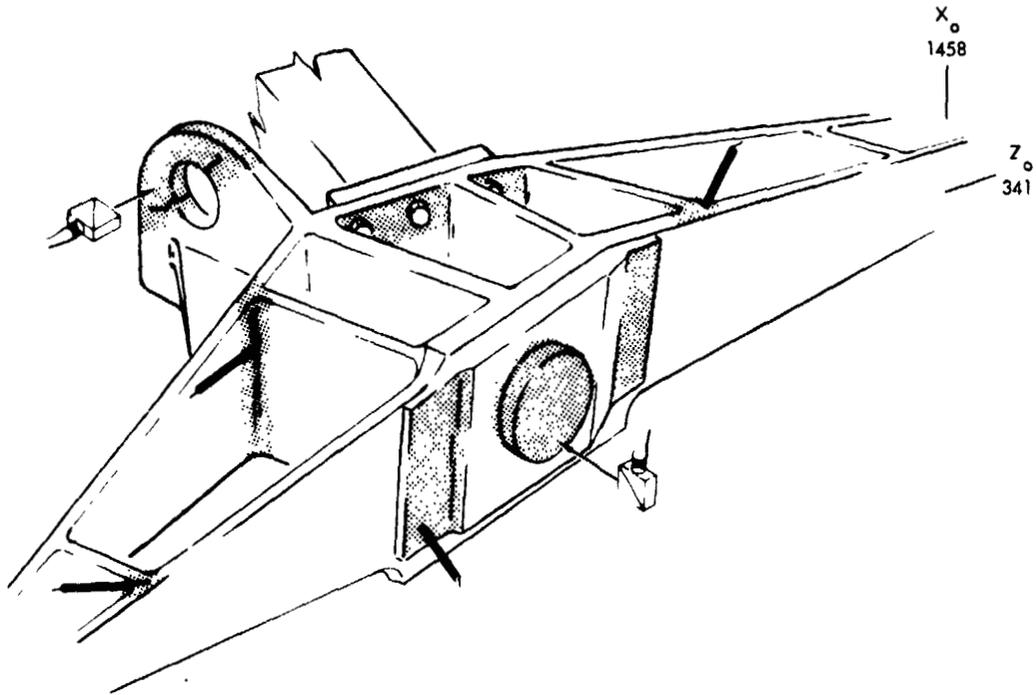
Figure 4-15. Main Engine Support and Gimbal Points (Sheet 2 of 2)

MAIN ENGINE NO. 3, GIMBAL POINTS
ME NO. 2 SIMILAR

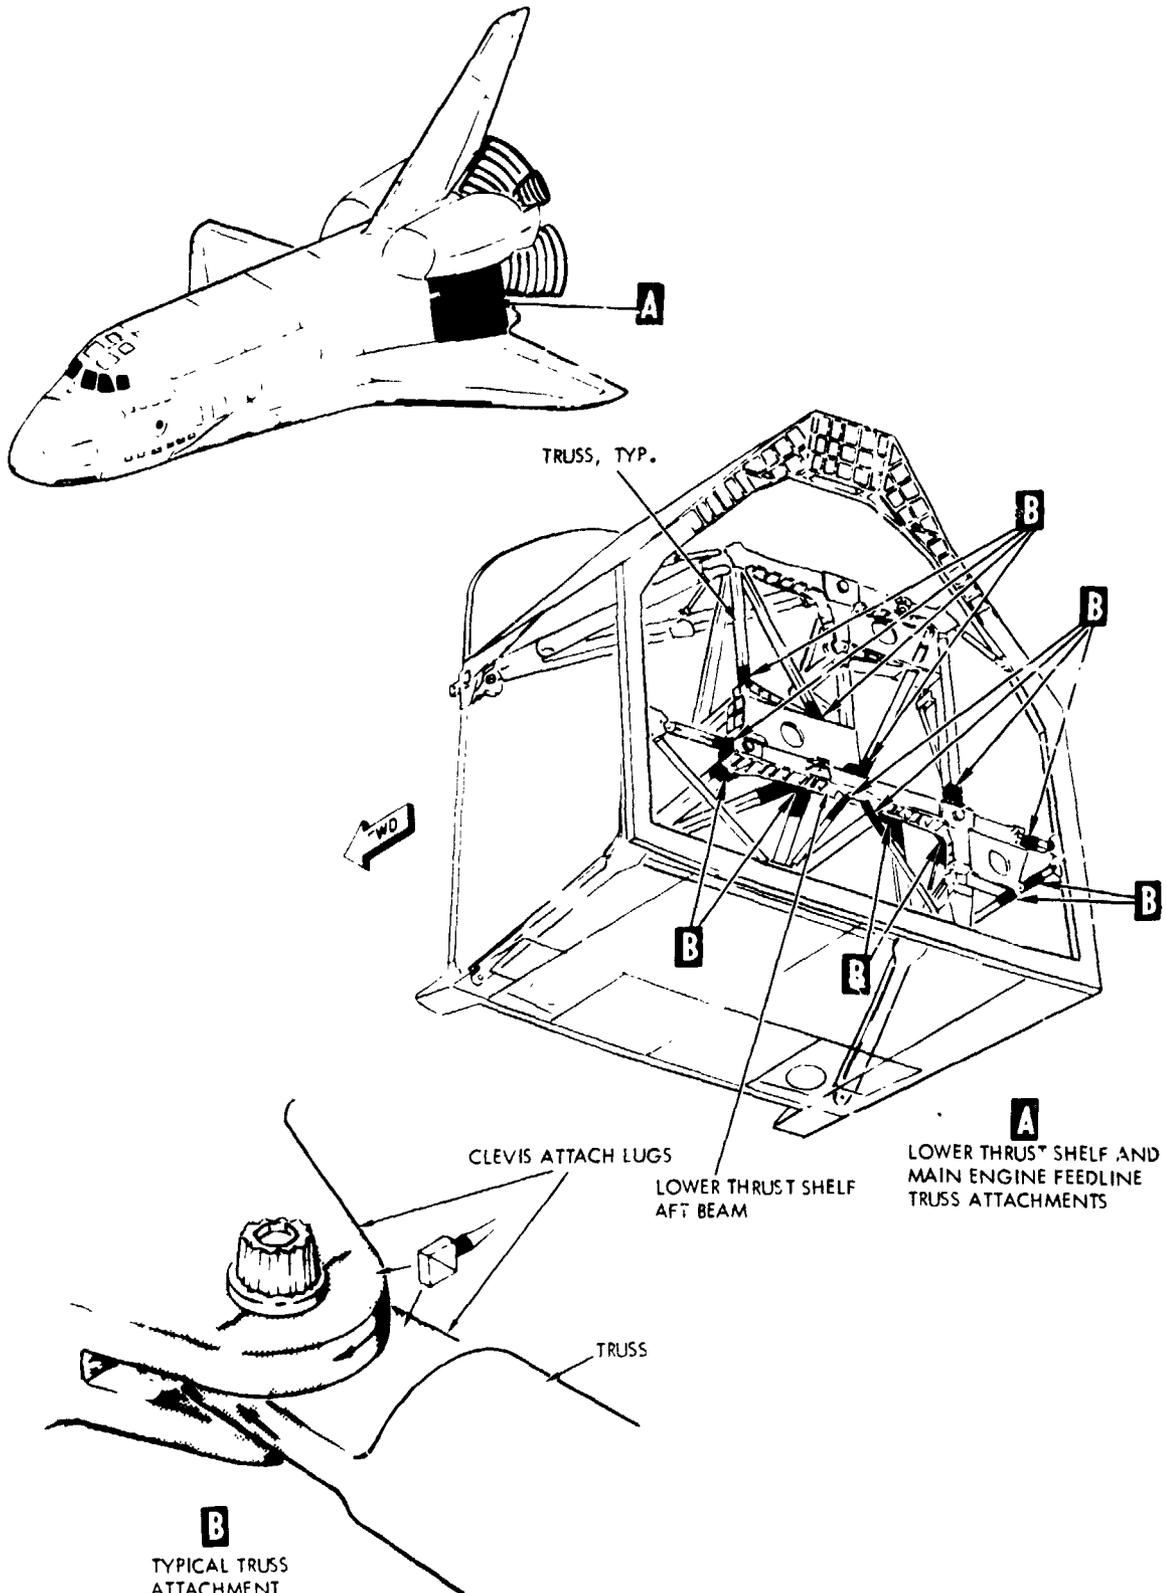
Figure 4-16. Lower Thrust Shelf and Main Engine Feedline Support Attachments

COMPONENT/AREA DESCRIPTION: LOWER THRUST SHELF AND MAIN ENGINE FEEDLINE ATTACHMENTS. Areas on the lower shelf thrust beam where attachments are made to the vertical thrust and lateral trusses and engine feedline supports may initiate fatigue damage due to engine thrust and vibro-acoustic loads reacted through these points. The material of construction for the components is titanium-6Al-4V. The inspection areas consist of lugs, base-plate attachments and lug-to-beam fillets.

DEFECTS: Cracks at bolt holes in both the lower shelf beam and truss lugs and at the lug-base fillets.

NDT TECHNIQUES: Primary: Ultrasonic shear wave (para. 1.5.5.3 B) and eddy current surface probe (para. 1.5.4.4)

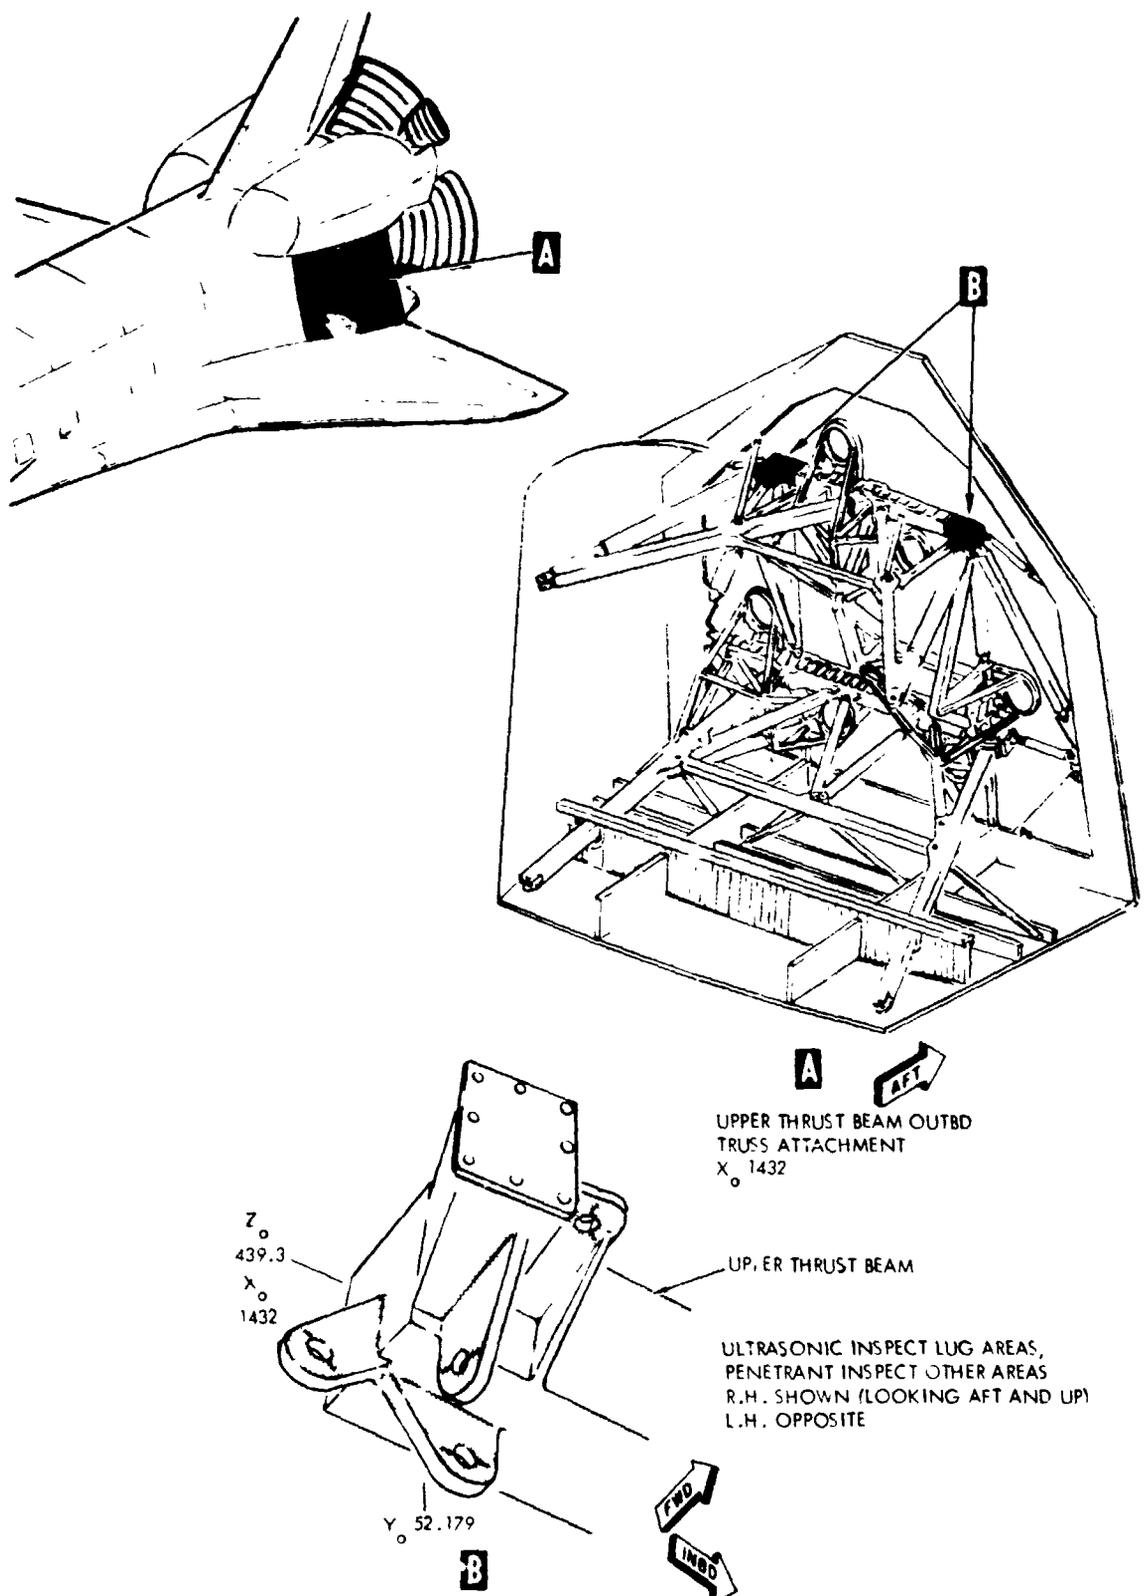
Figure 4-17. Upper Thrust Shelf and Main Engine #1 Feedline Support Attachments

COMPONENT/AREA DESCRIPTION: UPPER THRUST SHELF AND MAIN ENGINE NO. 1 FEEDLINE SUPPORT ATTACHMENTS. Areas on the shelf where attachments are made to the upper shelf frame and the vertical thrust support trusses may be susceptible to fatigue damage because of high engine thrust and vibro-acoustic loads which are experienced at these points. The shelf beam is machined from titanium-6Al-4V alloy. The points are located at the outboard attachment areas to the vertical support trusses, the ME #1 feedline support trusses, and at the attachments to the upper shelf frame.

DEFECTS: Cracks around bolt holes in lugs or where the lug blends into the base.

NDT TECHNIQUES: Primary: Ultrasonic shear wave (para. 1.5.5.3 B) for lug-base fillets

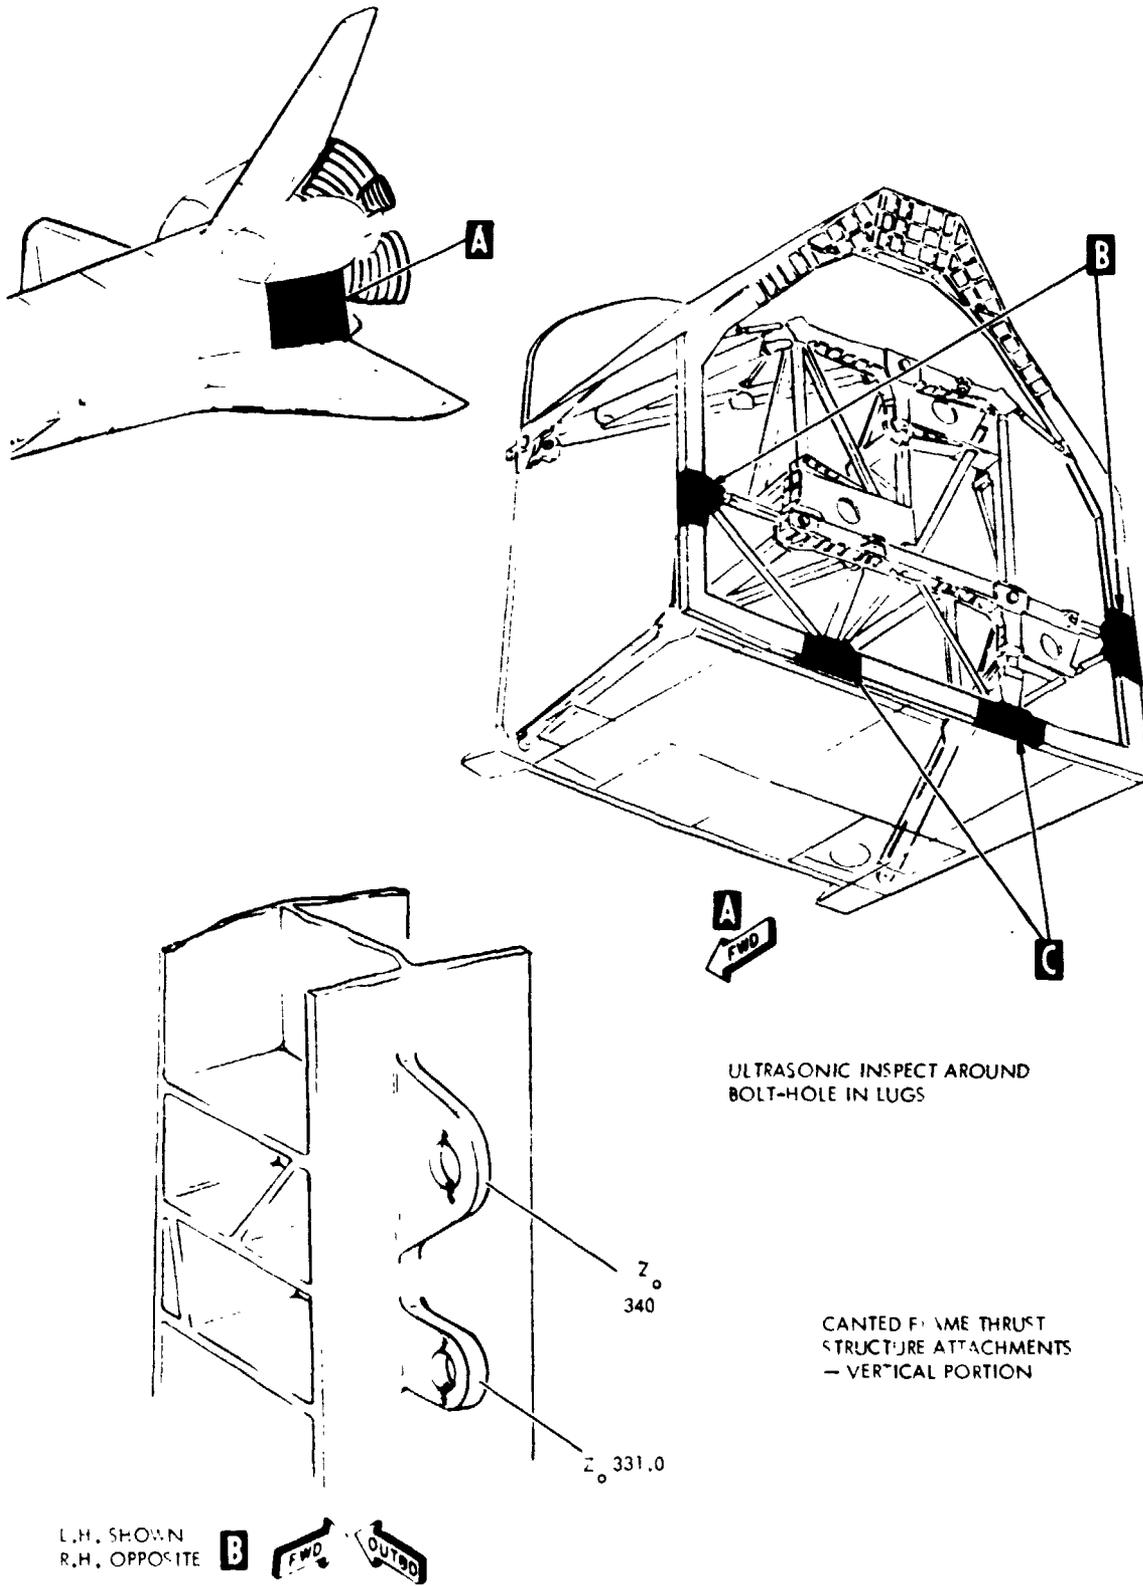
Figure 4-18. Canted Frame - Lower Portion (Sheet 1 of 2)

COMPONENT/AREA DESCRIPTION: CANTED FRAME (LWR PORTION). The canted frame is a principal member of the aft fuselage internal thrust structure which has clevis attachments for the main engine support structure and is spliced at the Z_o 415.77 water plane. The lower portion of the frame is a Ti-6Al-4V titanium alloy machined plate member which attaches directly to the main engine actuator support structure. The frame partially reacts fin drag and engine thrust loads. An engine-out condition will cause unsymmetric loads affecting actuator structure attachment points and frame splices.

DEFECTS: Radial cracks in lug holes providing canted frame-to-engine actuator structure attachments; part-through cracks at the base of attachment lugs; radial cracks in bolt holes at canted frame splice joints at Z_o 415.77.

NDT TECHNIQUES: Primary: Ultrasonic shear wave (para. 1.5.5.3 B) for lugs and longitudinal wave (para. 1.5.5.3 A) for splice pulse-echo techniques.

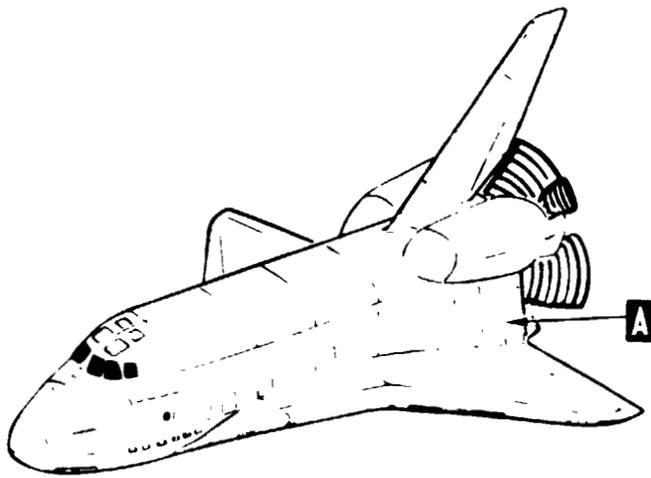
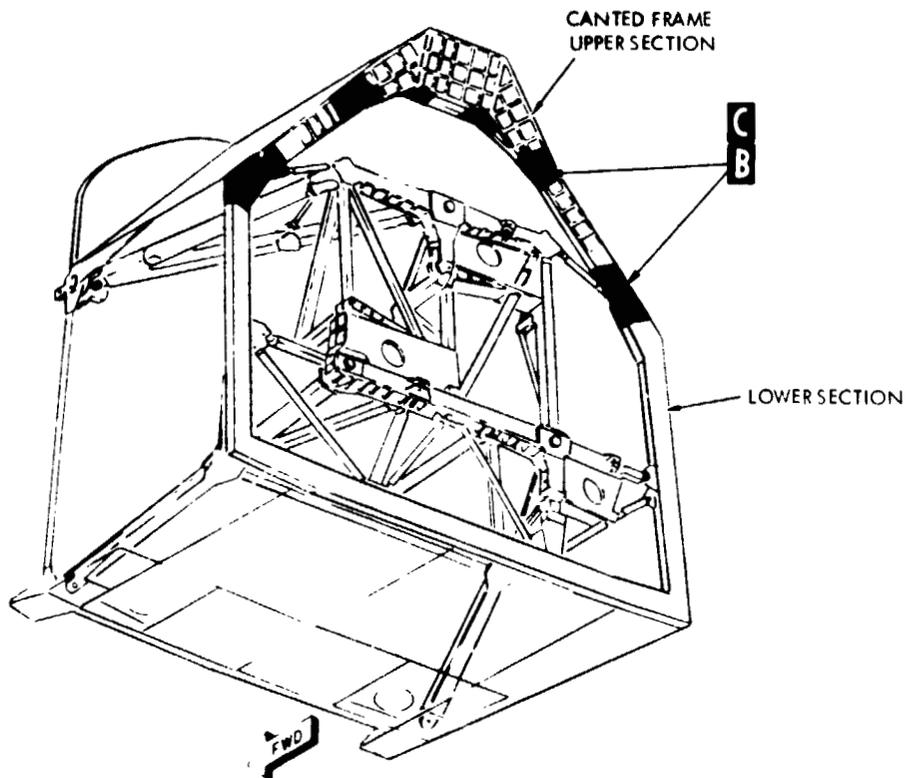
FIG 4-19. Canted Frame - Upper Portion (Sheet 1 of 2)

The canted frame is a principal member of the main engine thrust structure, having clevis attach points for the main engine support frames and is spliced at the Z_o 415.77' water plane. The upper portion of the canted frame is machined from 2124-T851 aluminum alloy plate (lwr half) and diffusion bonded titanium-6Al-4V alloy (upper half), and provides support for the vertical fin and has lateral attachments for the main engine support frames. It is spliced to the titanium lower canted frame. An engine-out condition will cause unsymmetric loads affecting actuator structure attachment points and frame splices.

DEFECTS: Radial cracks in the lug holes which provide canted frame-to-engine actuator structure attachments and in bolt holes at the canted frame splice at Z_o 415.77; part-through cracks at the base of attachment lugs; edge cracks along titanium upper portion of frame cap.

THRUST STRUCTURE CANTED FRAME, UPPER SECTION

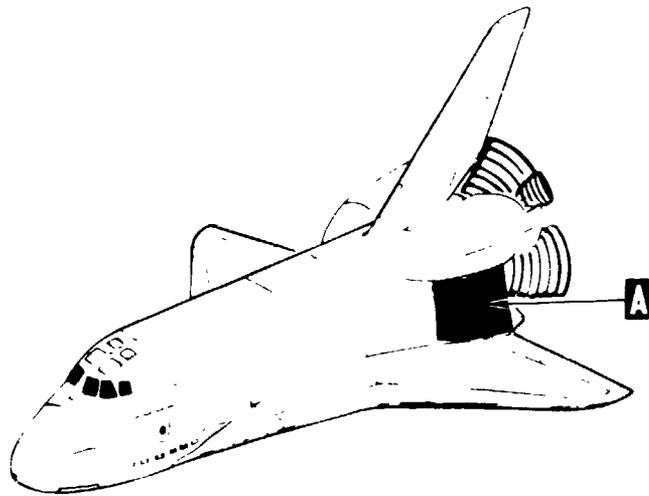
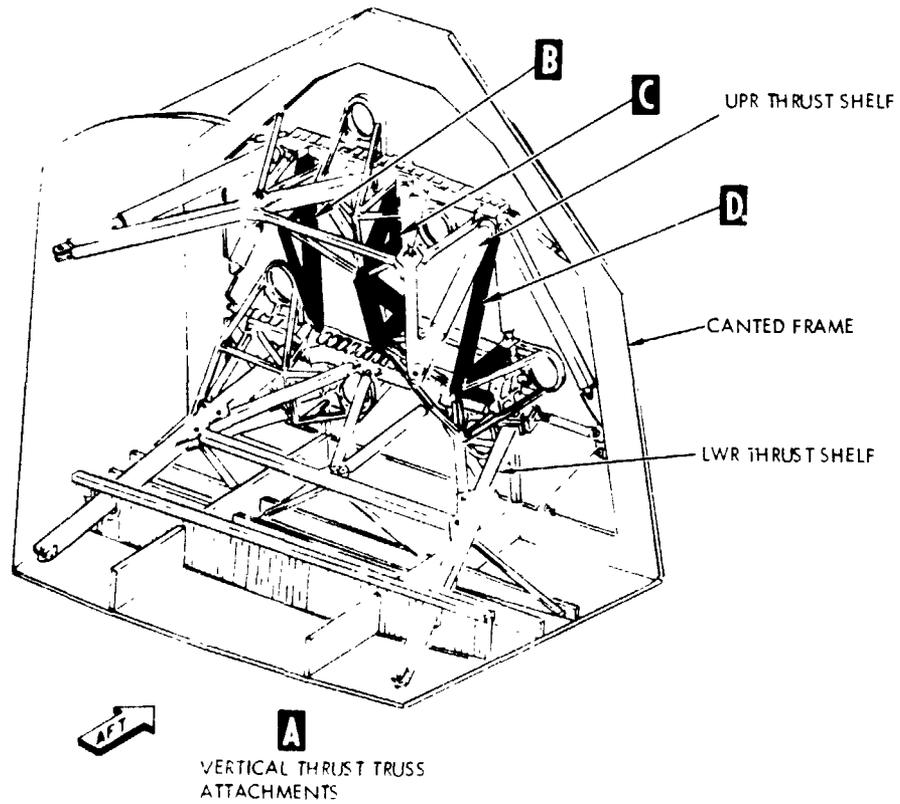
Figure 4-20. Vertical Thrust Truss Attachments (Sheet 1 of 3)

ATTACHMENTS (LH, RH AND CENTER). The upper and lower thrust shelves are stabilized by three interconnecting titanium-6Al-4V thrust plane trusses which are reinforced by additional trusses. The clevis attachment areas common to the vertical trusses and their support trusses may experience fatigue damage due to main engine thrust and vibroacoustic loads.

DEFECTS: Radial cracks at clevis bolt holes in attachment lugs and pads and part-through cracks at the lug-base fillets.

NDT TECHNIQUES: Primary: Ultrasonic shear wave (para. 1.5.5.3 B) for lug clevis attachment areas and eddy current (para. 1.5.4.4) for lug fillets.

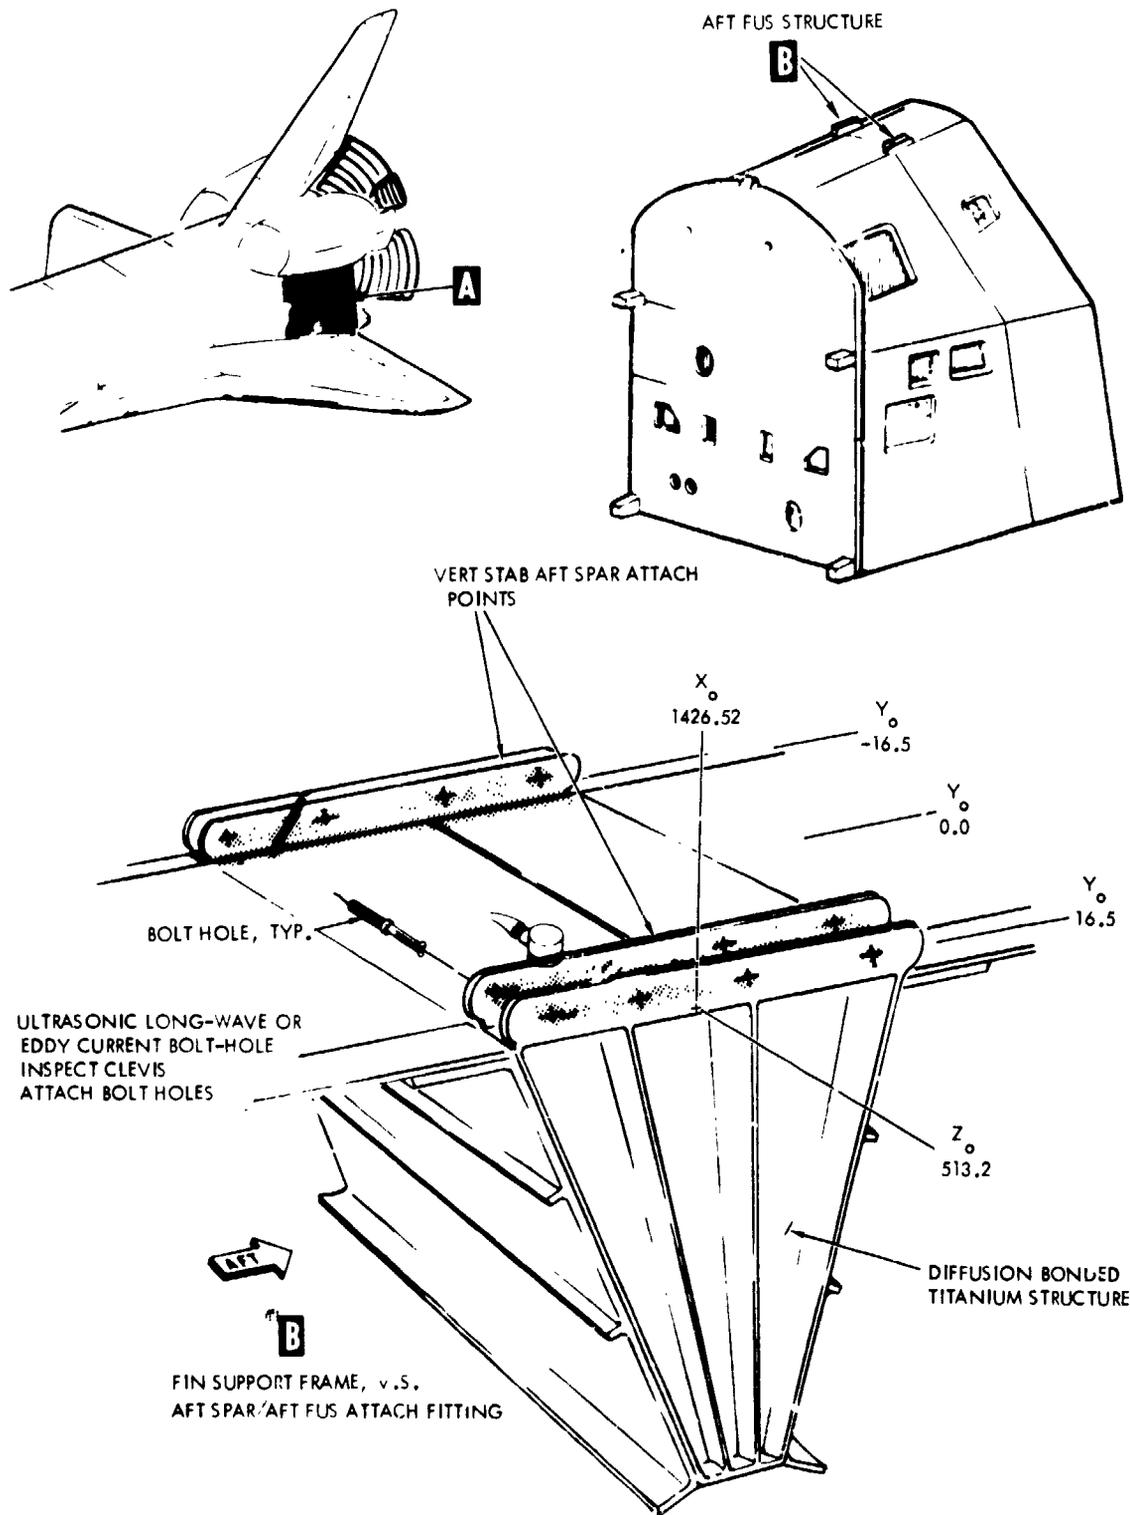
Figure 4-21. Fin Support Frame, Clevis Attach

AREA. This safe-life component forms the upper end of the vertical fin support frame and contains the clevis attach lugs that mate with the vertical stabilizer-fuselage aft attach plate. This component transfers the vertical stabilizer rear spar loads into the aft fus structure. The frame is made of titanium-6Al-4V alloy in the annealed temper, and is located at $X_o = 1426$, $Z_o = 513$, and $Y_o = \pm 16.5$. Flight loads imposed through the vertical stabilizer rear spar attachment may produce fatigue damage in the clevis bolt holes.

DEFECTS: Corner or through-cracks at the edge of the clevis bolt holes in the attachment lugs.

NDT TECHNIQUES: Primary: Use eddy current bolt hole probe (para. 1.5.4.3) with clevis bolt removed - or if top edge of attachment flanges are accessible, use ultrasonic p.e. longitudinal wave (para. 1.5.5.3 A); use eddy current (para. 1.5.4.4) for fillets.
